1
2
3
4
5
6
7
8 UNITED STATES DISTRICT COURT
9 NORTHERN DISTRICT OF CALIFORNIA
10 SAN FRANCISCO DIVISION

11 IN RE SEAGATE TECHNOLOGY LLC
12 LITIGATION

13 DECLARATION OF ANDREW
14 HOSPODOR IN SUPPORT OF
15 PLAINTIFFS' MOTION FOR CLASS
16 CERTIFICATION

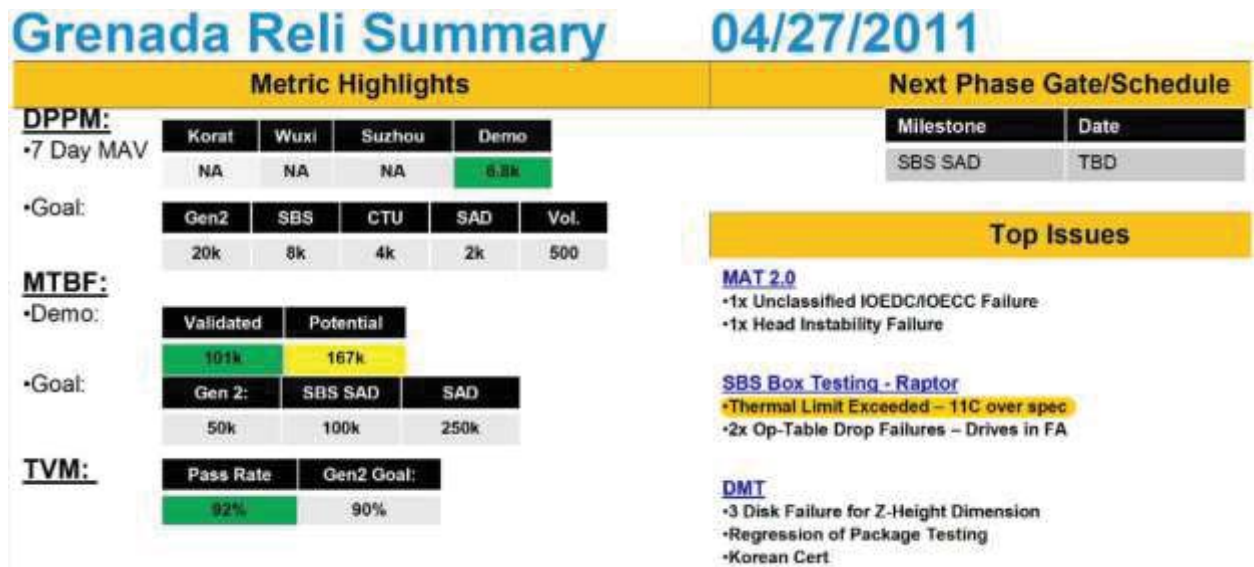
Figure 6: Grenada Reliability Summary Showing a Large Over-Temperature Problem (FED_SEAG0026697, at 26703) (highlight added)

68. Notably, this page indicates that, when the case temperature for the Desktop External Drive³³ was tested, the Drive was 11°C above the temperature limit. It is well known that the reliability of almost all products is a strong function of temperature. Indeed, this is what Seagate has to say on the topic:

69. The SAD indicates that the Desktop External Drive was not approved for release at the time of the SAD document due to temperature and drop test failures.³⁵

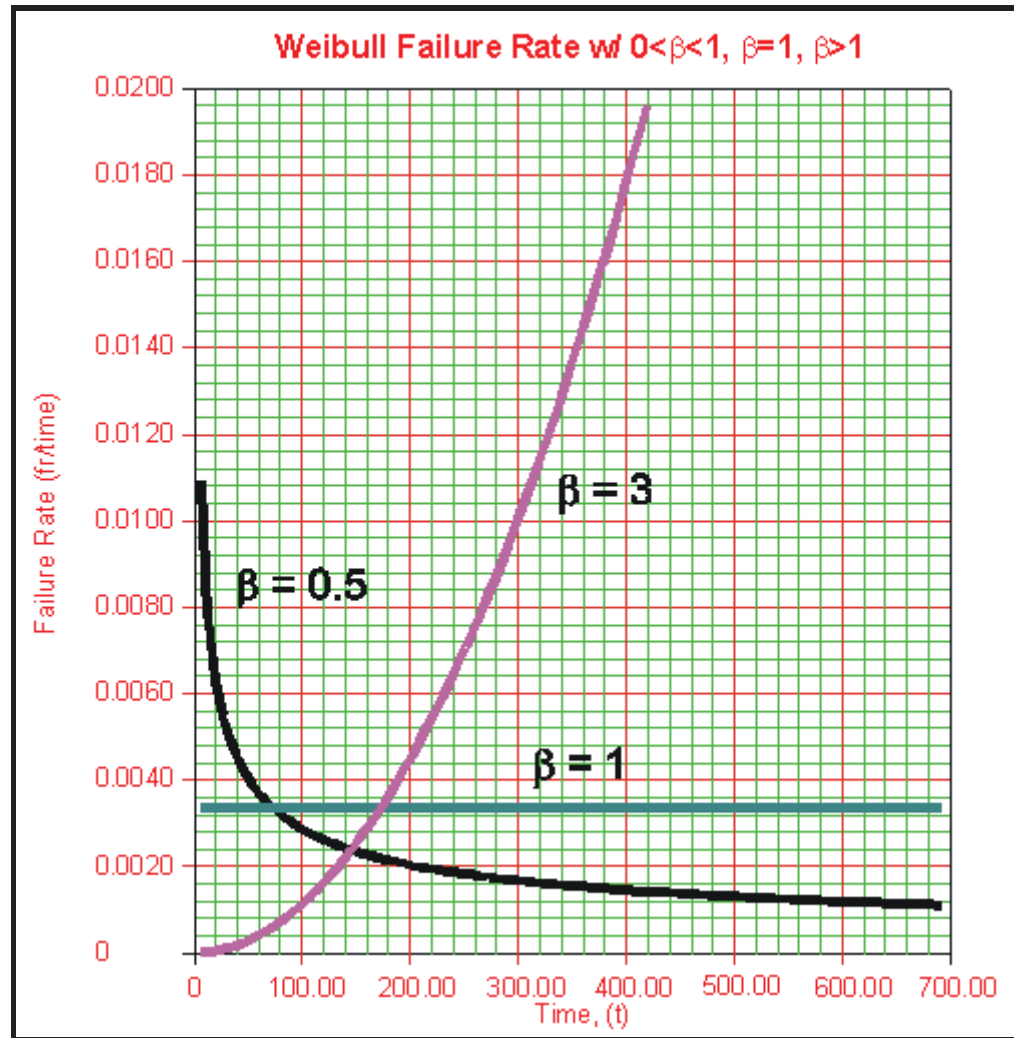
Figure 9: Weibull Failure rate as a function of beta

93. This graph in Figure 9 is widely referred to as a “bathtub curve.” It shows that a β of less than 1 is indicative of a population with a failure rate that decreases over time. This is often referred to as “infant mortality,” because defective products fail quickly and are thus weeded out, leaving a reduced failure rate as time goes on. A β of around 1 indicates a constant failure rate and would reflect the useful life of a product with random failures. Finally, a β of more than 1 indicates that the failure rate is increasing with time and that the product is wearing out.

94. As discussed in Section F, Seagate computed a β of 0.608098 (i.e. a value of less than one) for the release of the Drive to Seagate Branded Solutions customers. Seagate also computed a β of less than one for all of the other reliability testing it conducted. This β value represents an assumption that the Drive will have a declining failure rate over time.

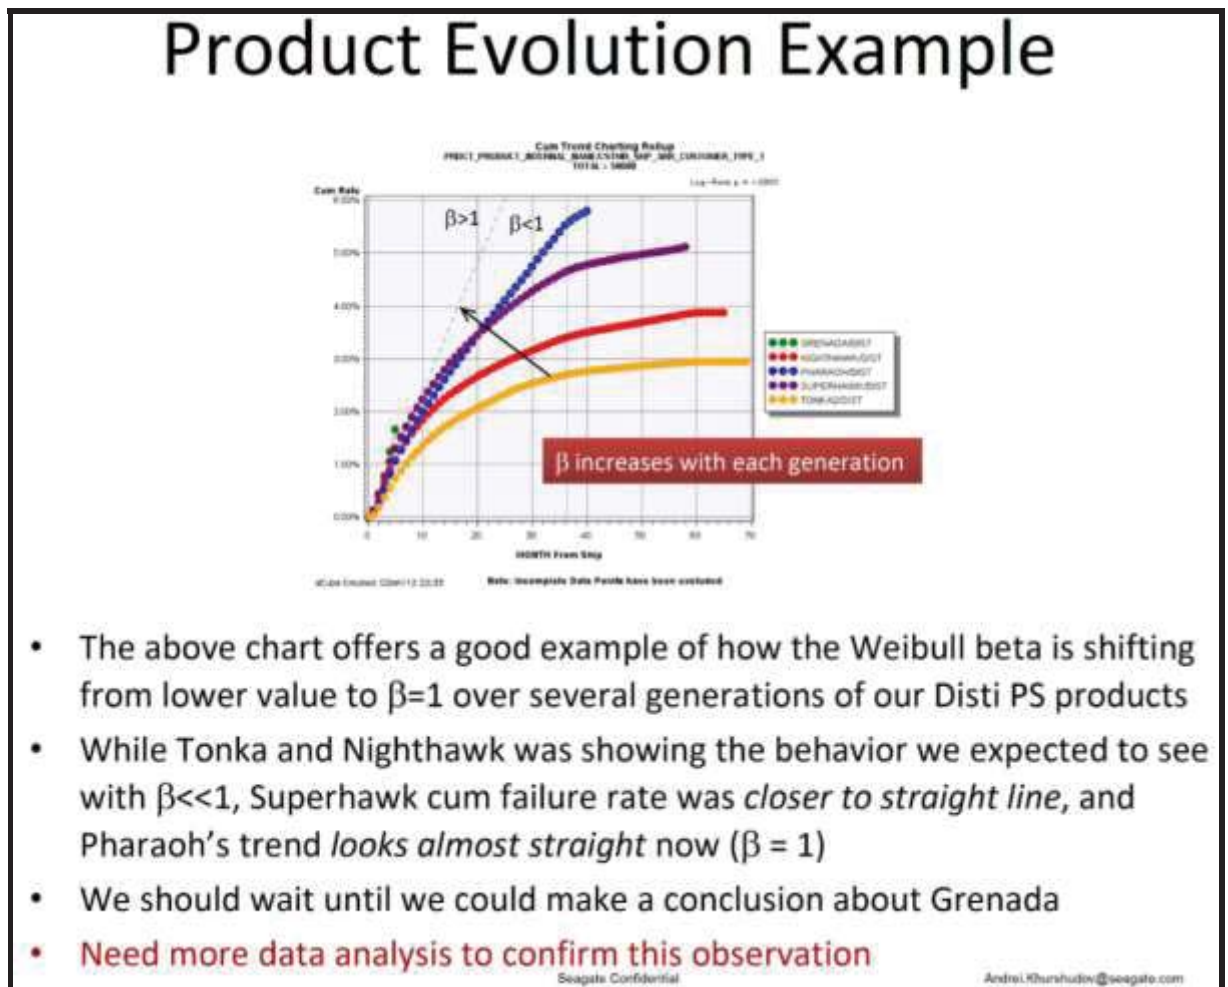
Figure 12: Dr. Khurshudov showing how β is changing with drive generation (FED_SEAG0001857)

101. Grenada (in green) was the most recent generation and appears to have had the worst performance (largest β). Note, however, that Dr. Khurshudov was not comfortable drawing conclusions about Grenada until he had more than just six months data, but it appears that he did not later update the report. Notwithstanding this, the graph shows a clear progression from $\beta < 1$ to $\beta > 1$, with the data points of the Grenada falling in the $\beta > 1$ range.

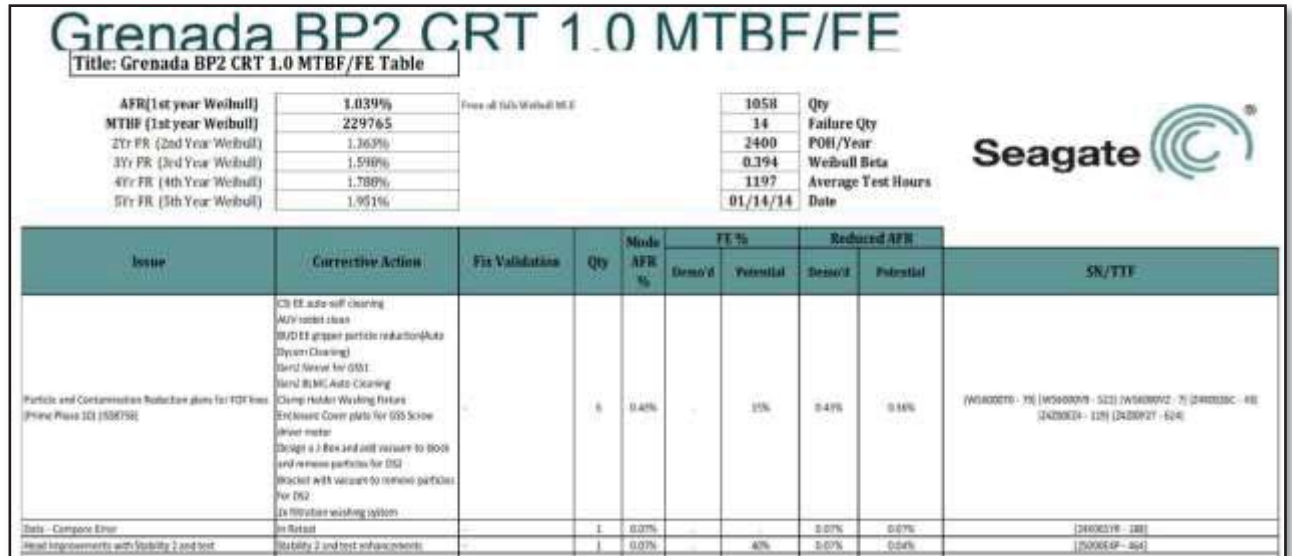
Figure 14: Grenada BP2 reliability test results (FED_SEAG0057277, 57324)

113. Here, Seagate tested 1058 Drives for an average of 1197 hours, which is approximately seven weeks, and the Weibull β was 0.394. Unlike prior reliability testing, Seagate projected the AFR for the first through fifth years, rather than just the first year, and the AFR increased from 1.039% in the first year to 1.951% in the fifth year.

114. I cannot reconcile this increasing failure rate with the use of a Weibull β of 0.394, because a β of <1 reflects a decreasing failure rate. The fact that Seagate came up with a β of >1 , projecting an increasing failure rate, further suggests that Seagate's testing was deeply flawed. In any event, the increasing AFR demonstrates that the ST3000DM001 was projected to have significant wear-out failures within its five-year expected service life. If a β of greater than one had been used, it is likely that the projected AFR would have been even higher.

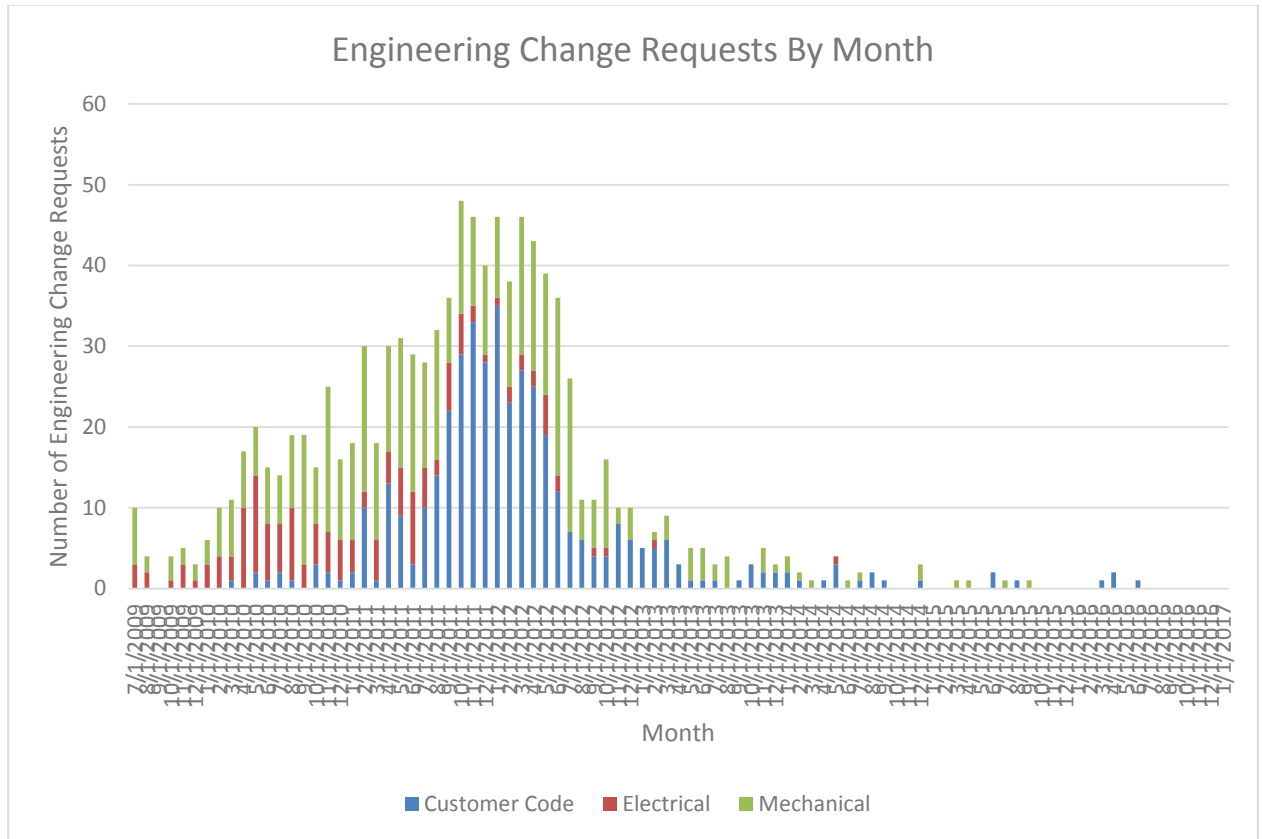
Figure 19: Graph of Grenada Classic ECR by month

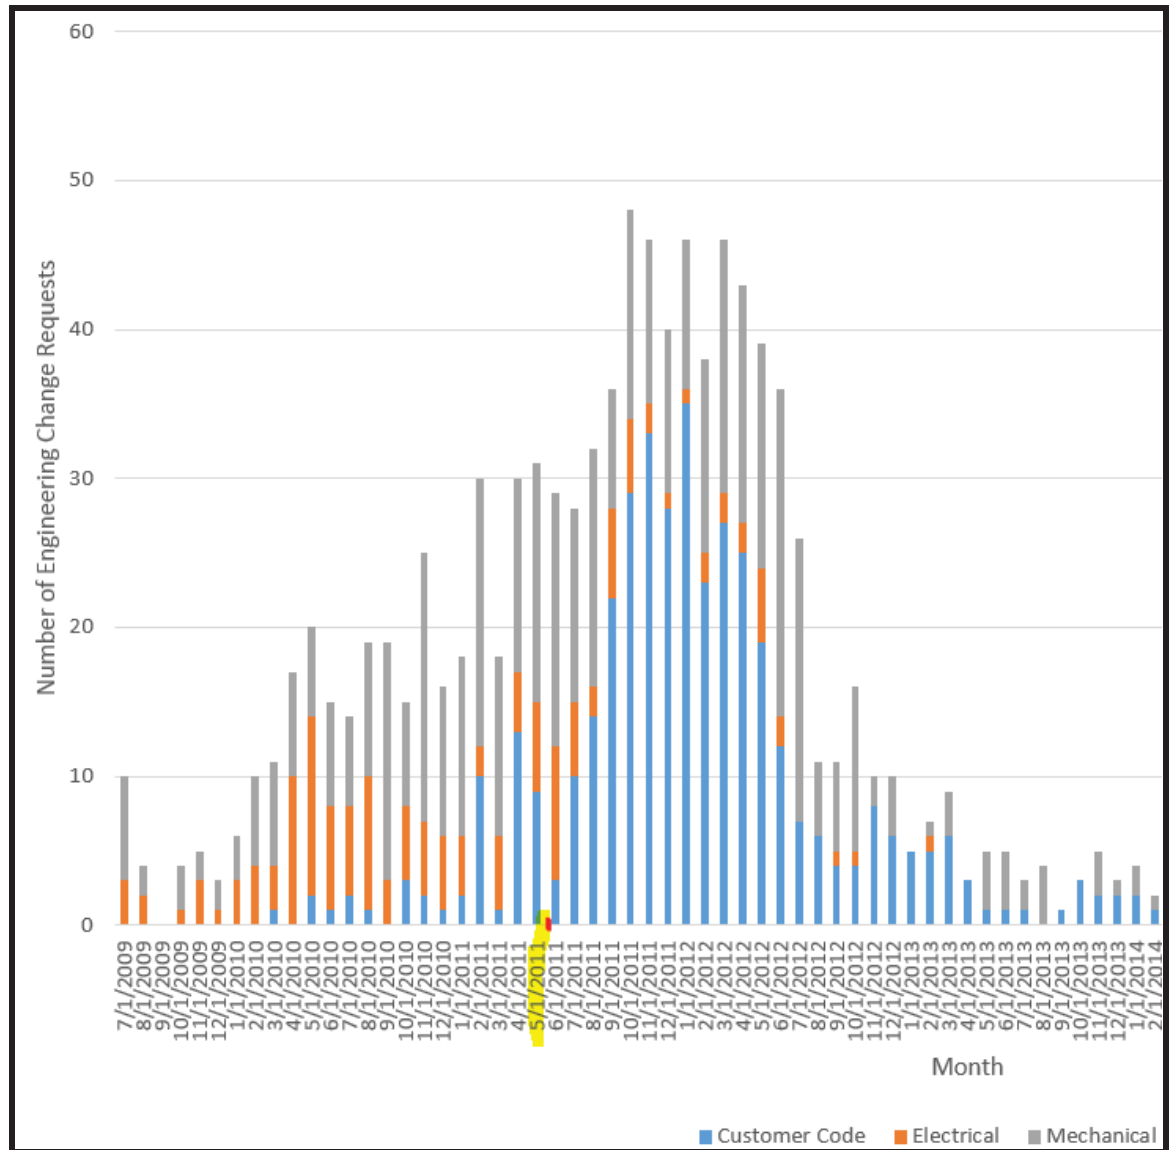
Figure 20: First few years of Grenada Classic ECR

133. The above graph shows that in the year following the initial release of the Drive, at least 30 ECRs were raised every month, and for much of that time there were more than 40 ECRs raised each month. This means that on average, an ECR was raised every single day for a year.

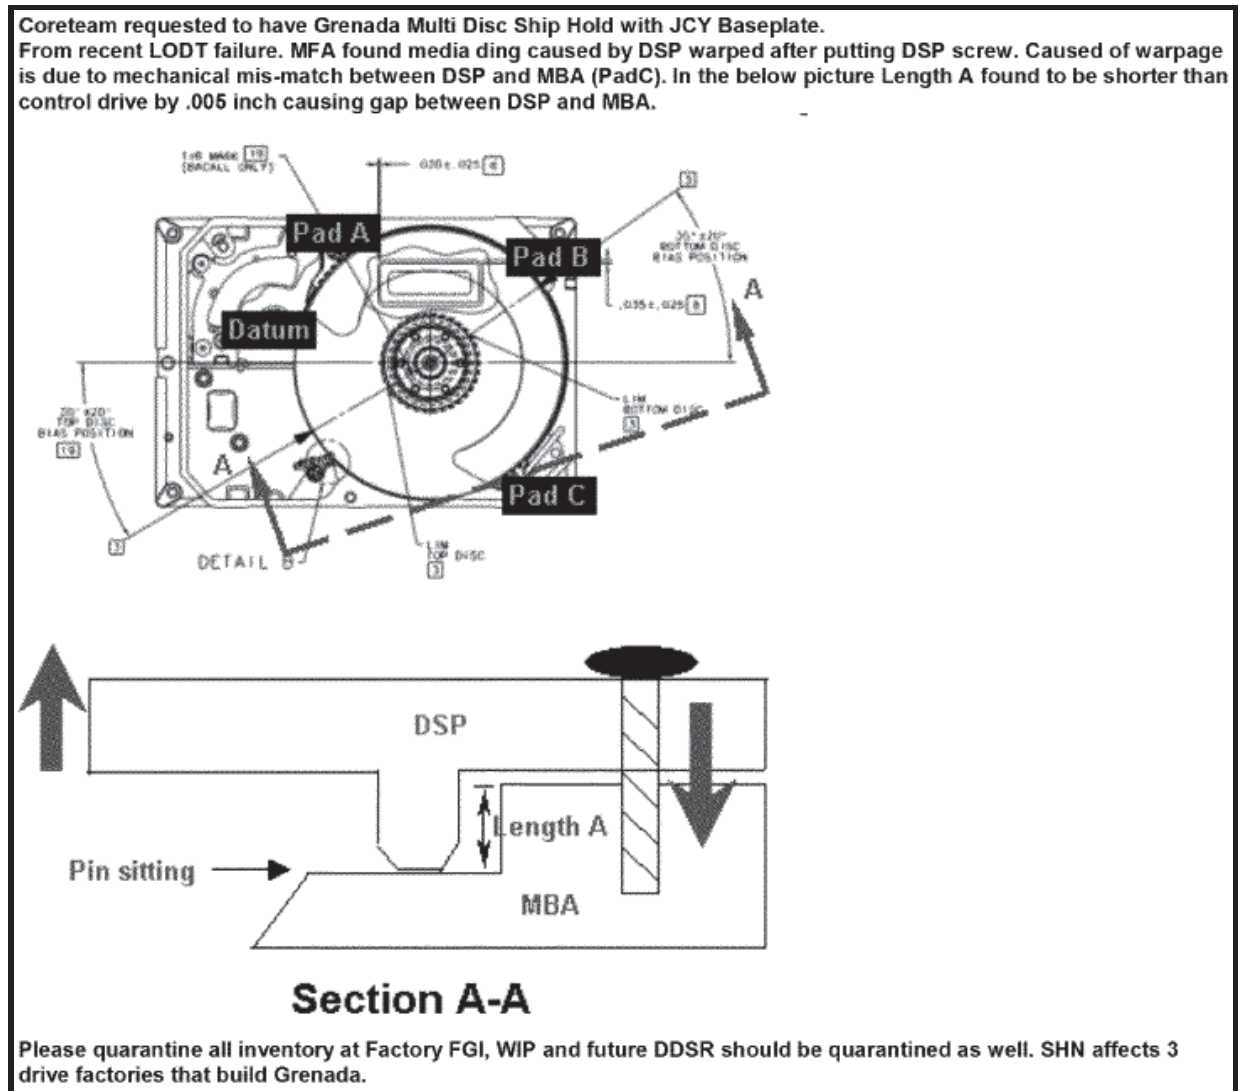
148. The DSP hold was put in place due to a mechanical mismatch between the DSP and a component called the motor base assembly (“MBA”), such that the DSP became warped after putting in the DSP screw. A diagram of the DSP and MBA is below.

Figure 23: Details on DSP Tolerance Problem. FED_SEAG0008927, at 8928

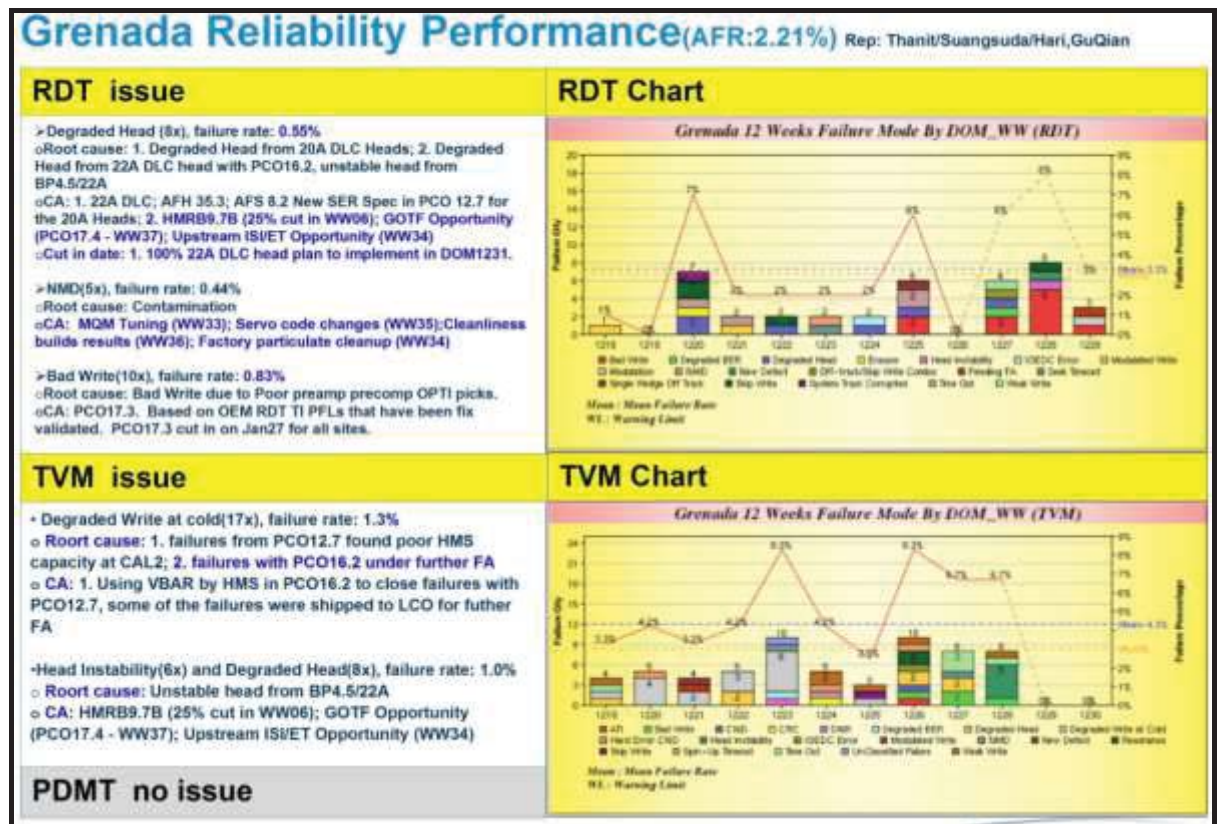
Figure 25: FED_SEAG0009670, at 9678

176. The ship holds, as well as other documents produced by Seagate during discovery, indicate that the ST3000DM001 was unreliable, unstable, and defective, and that problems with the Drive began to manifest shortly after its release and escalated in early 2012. The figures below are from February 2012. Note that the dates shown in the charts (e.g. 1218) refer to week 18 in financial year 2012. Figure 25 shows that Grenada's projected AFR was 2.21% and that its failure percentages were constantly above the warning levels. The main factors driving the elevated failure rate included "degraded heads," "head instability," and "NMD" (new media defect) caused by contamination. Disk drive heads are very sensitive devices that fly over the disk media so closely that a human hair would cause them to crash. Heads degrade when subject to abrasion from contacting the disk, sometimes damaging the media as well. A head that collects contaminants or excessive lubricant on its air bearing surface will fly higher and generate more heat due to increased friction. The combination of increased flying height and increased Johnson noise, proportional to temperature, leads to new defects when writing data and reading back from the disk. In the worst case, the areas of the disk with heavy contaminants may trigger new media defects that are added to the defect list after the disk leaves the manufacturing facility.

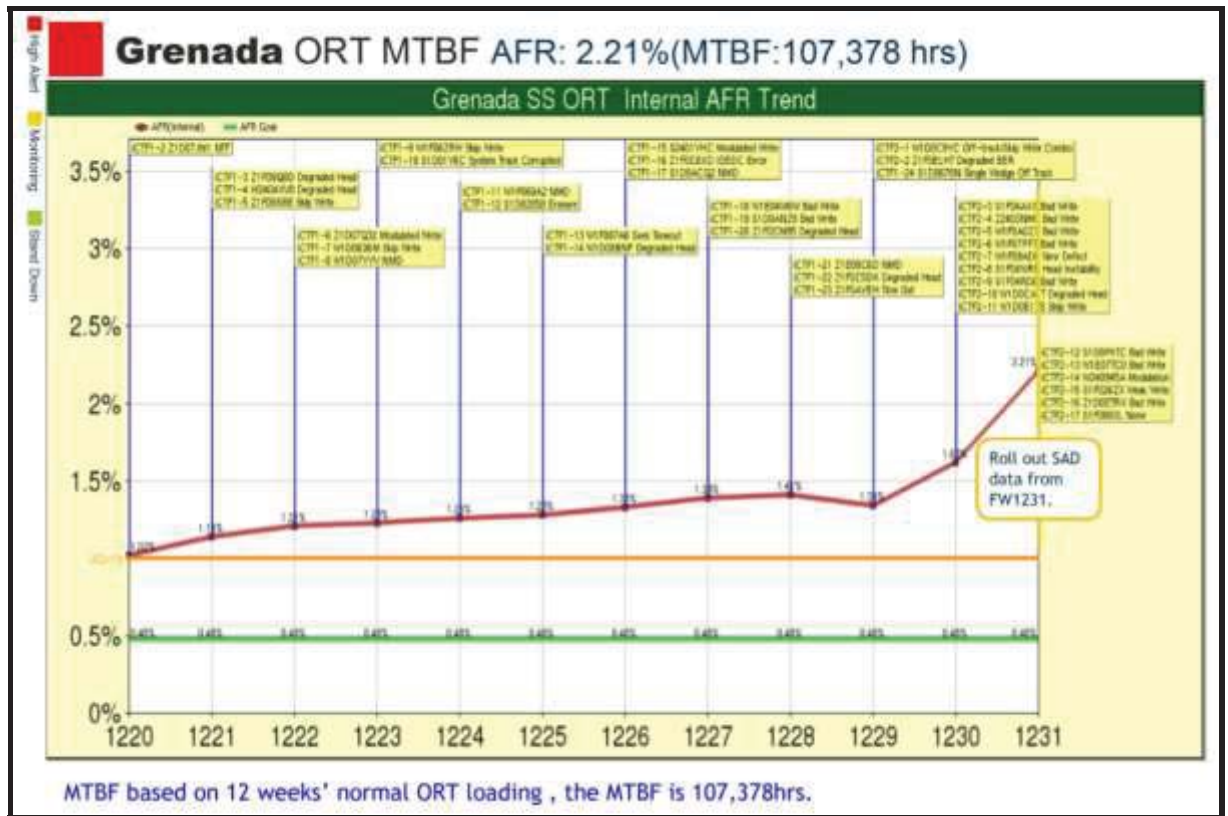
Figure 26: FED_SEAG0009670, at 9681

177. Figure 26, below, shows in dramatic fashion that not only were the problems bad – but they were getting steadily worse. The green line at 0.5% represents Seagate’s target. The orange line at 1% AFR is marked as “UCL” or Upper Control Limit. It can be seen that the actual projected AFR based on ORT (Ongoing Reliability Testing) is above 1% for 12 weeks straight and is rapidly increasing at the end of the period.

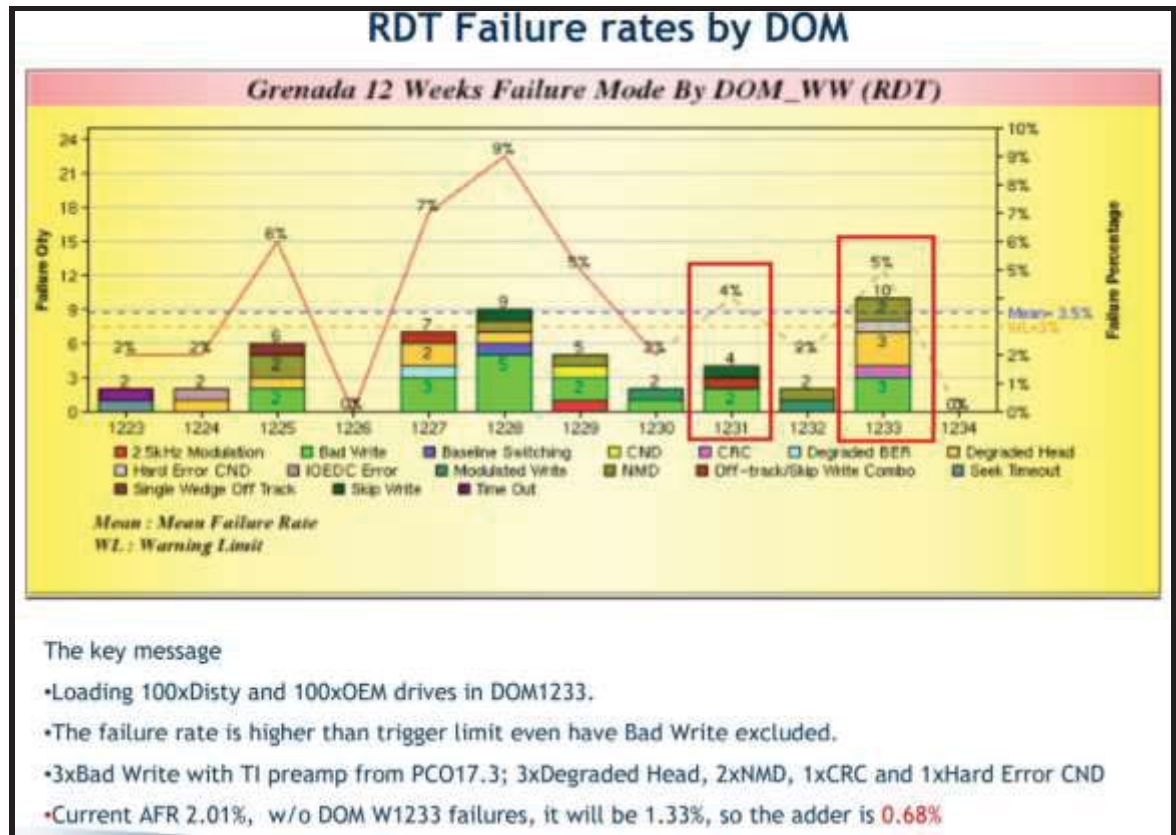
Figure 27: FED_SEAG0009576, at 9580

178. Figure 27, below, provides an analysis using RDT (Reliability Demonstration Testing). It extends a few weeks more into 2012 work week 34 and shows that work week 33 was the worst week yet.
